National Transportation Safety Board

Safety Recommendation

Date: June 16, 2000

In reply refer to: A-00-32 through -40

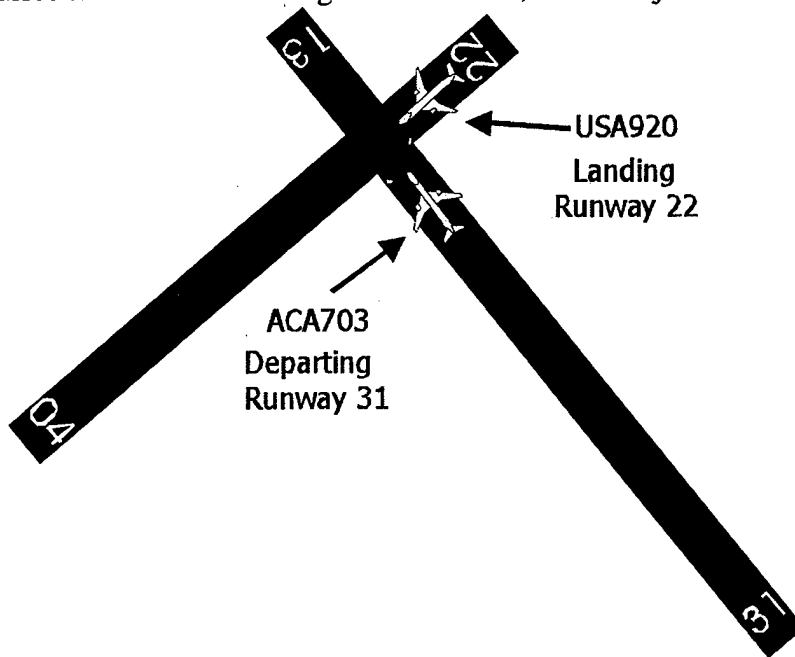
Figure 1. Approximate aircraft orientation for April 3, 1998, near midair collision (NMAC) at LGA

At the time of the incident, aircraft landing at LGA were using runway 22 and departing aircraft were using runway 31. Runway 22 intersects runway 31 approximately 5,300 feet from the threshold of runway 31. According to the LGA tower local controller, USA920 was executing a visual approach to runway 22 and had been cleared to land. The local controller then cleared ACA703 for takeoff from runway 31. Approximately 30 seconds later, he reassessed the traffic situation and decided that ACA703 would not clear the intersection before USA920 crossed the threshold of runway 22.¹ The local controller then instructed USA920 to go around.² ACA703 was airborne and climbing before it reached the intersection with runway 22; consequently, USA920 and ACA703 were in the air when their paths crossed. The captain of USA920 saw ACA703 on his left and alerted the first officer, who was flying the airplane. The first officer immediately took evasive action to avoid a collision. Radar data were not available because both airplanes were below radar coverage at the time of the incident; however, in the NMAC report he filed with the FAA, the captain of USA920 estimated that his aircraft passed 85 feet below ACA703 with horizontal separation of 75 feet. The local controller estimated the separation distance at 20 feet.

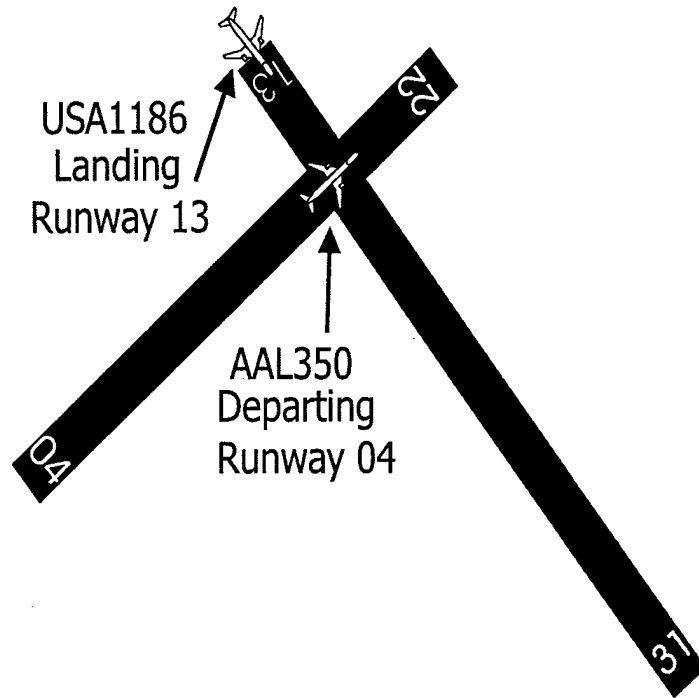
Figure 2. Approximate aircraft orientation for January 23, 1998, NMAC at LGA

The captain of AAL350 stated that he looked to his left as his aircraft passed through the runway 4/13 intersection and saw USA1186 approximately over the runway 13 threshold. Recorded air traffic control (ATC) communications indicate that after departure, one of the pilots of AAL350 said to the local controller, "that was close."
